# Effect of Microstructure on Hydrogen-Induced Cracking in Sour Service Pipeline Steel

M. O'Brien<sup>1</sup>, J.G. Speer<sup>1</sup>, K. O. Findley<sup>1</sup>

Keywords: Hydrogen-induced cracking, pipeline steel, grain boundary misorientation

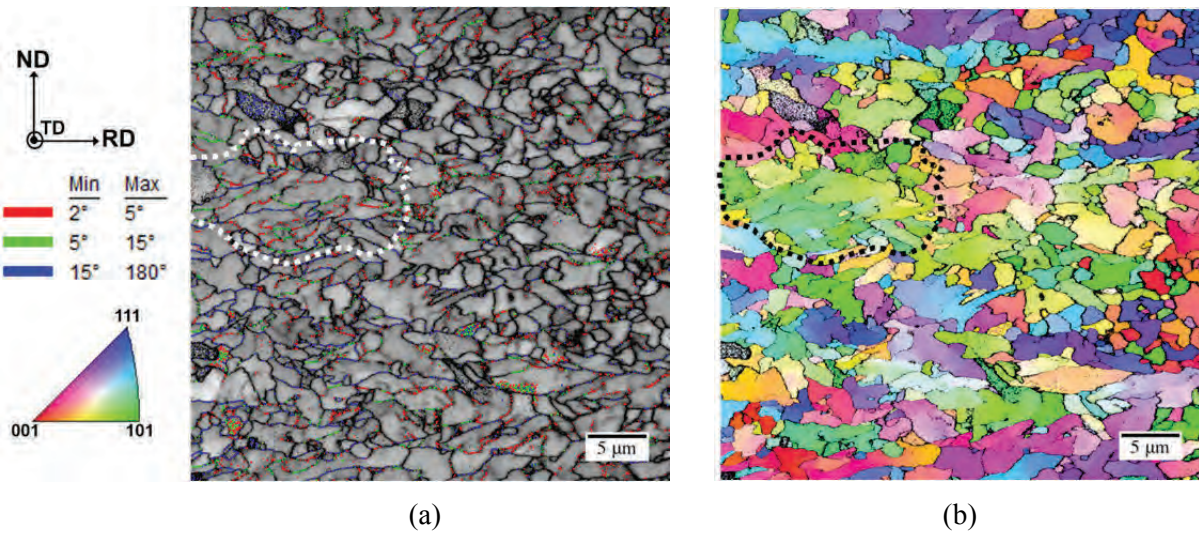
Figure 1. EBSD micrographs from the AR X70 steels where (a) is an IQ map with points having less than 0.2 CI displayed in black and grain boundary coloring overlaid according to the legend to the left and (b) is an IPF map of same region, with the stereographic triangle shown on the left, and points less than 0.2 CI displayed in black (*color image – see electronic copy*).

The X70 microstructure contains non-equiaxed highly substructured ferritic constituents with M/A microconstituents. EBSD micrographs were used to examine grain orientation, substructure, and morphology in the AR X70 microstructure. Figure 1a is an image quality (IQ) map with boundary misorientations overlaid, and Figure 1b is an inverse pole figure (IPF) map with points having less than 0.2 confidence index (CI) shown in black to allow for ease of identification of grain boundaries. Figure 1a and b indicate that the X70 steel contains both small equiaxed grains around 1 or 2 μm in diameter and larger (8 to 10 μm in diameter) elongated grains with several low angle boundaries having 2 to 15° misorientation as shown in Figure 1a. An important feature of note in the X70 microstructure is highlighted by dashed lines in Figure 1a and b which is a large region composed of grains with similar orientations. The boundary misorientations from 2 to 15° within these regions could be of importance during cracking, as dislocations and boundary structures play a role in hydrogen trapping or provide a path for crack propagation. These types of grains grouped with similar orientations are not as prevalent in lower strength alloys. The boundary misorientations from 2 to 15° within these large grains could be of importance during cracking, as dislocations and boundary structures can trap hydrogen or provide a path for crack propagation. The measured grain diameters ranges from 1 to 5 μm with a smaller number of large grains from 7 to 9 μm.

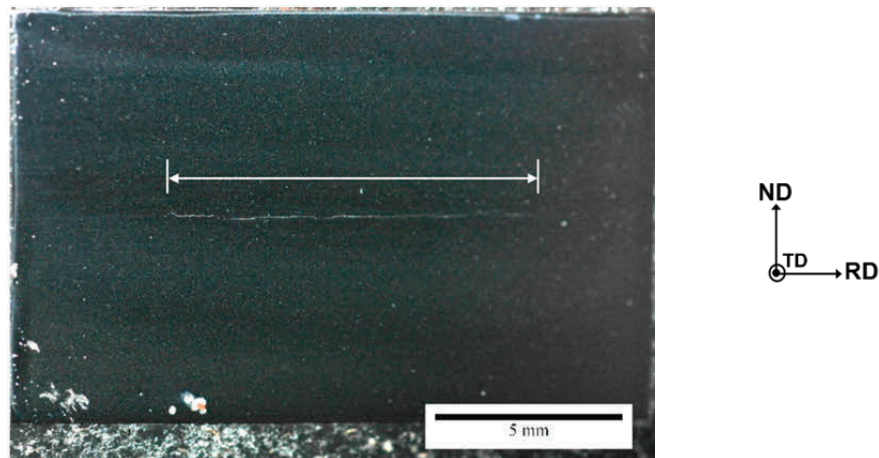
Figure 2. Photograph of a crack found at the centerline of the X70 sample charged with the NACE TM0284 charging method.<sup>18</sup>

Figure 2 is a photograph of a sample of the X70 alloy that was hydrogen charged using the procedure outlined in NACE Standard TM-0284. The crack in Figure 2 is about 10 mm in length in the rolling direction at the centerline. Most of the cracks in X70 samples occurred along the centerline but varied in length. Figure 3a is a SE micrograph from a vibropolished AR X70. An example of an M/A microconstituent is shown in the higher magnification image from the same region. Similarly, Figure 3b is an example EBSD image quality map showing M/A regions next to HIC. The ratio of M/A to total line length in the AR microstructure and the ratio of M/A length to total crack length in hydrogen charged samples are tabulated in Table II. The line fraction of M/A microconstituents along a crack is approximately 4 pct., while the line fraction of M/A constituents at the centerline of the as-received microstructure is 3.6 pct. This small difference between M/A line fraction along the crack path compared to the line fraction of M/A in the AR microstructure indicates that M/A microconstituents do not preferentially crack relative to the ferritic microstructure, in contrast to previous literature. It is important to note, however, that this line fraction assessment does not directly quantify the role that M/A constituents have in hydrogen trapping and diffusion, but rather assesses the vulnerability of M/A to cracking compared to the ferritic matrix.

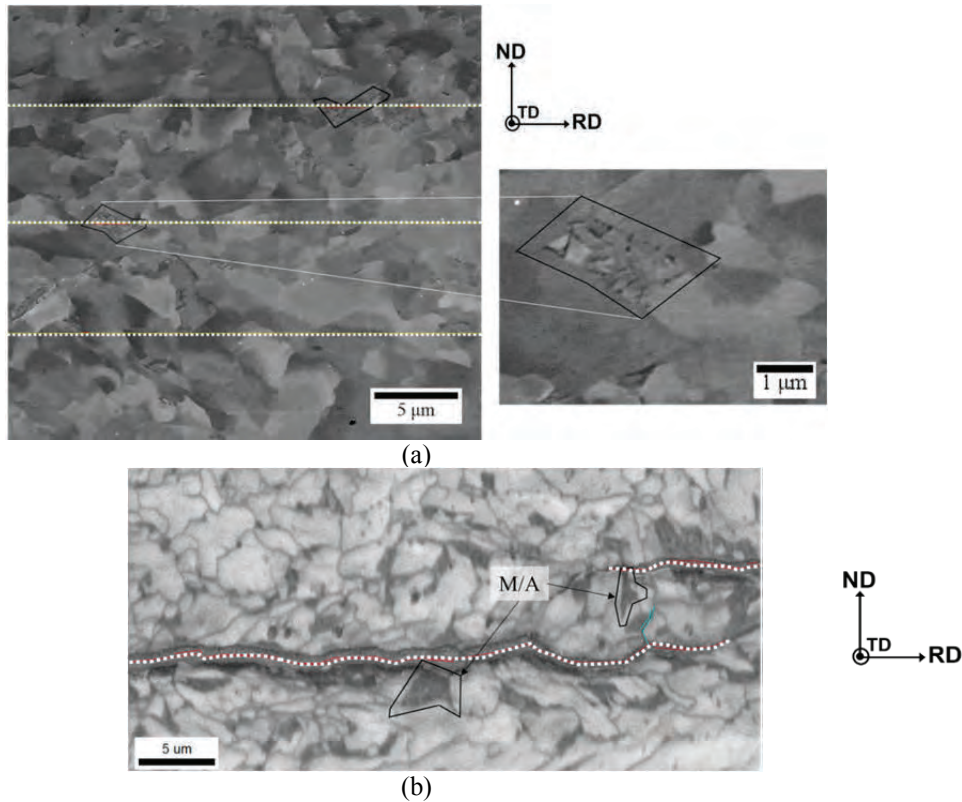
Figure 3. Micrographs from the X70 steel where (a) is a SE micrograph from the AR X70 steel with some of the M/A constituents identified, and dashed white lines represent the measurement lines. (b) EBSD IQ map obtained from an X70 steel charged with hydrogen using NACE TM-0284<sup>18</sup> with M/A microconstituents directly adjacent to cracks identified as distinct dark regions and outlined in black. In addition, the white dashed lines are examples of crack length measurements taken using ImageJ software.

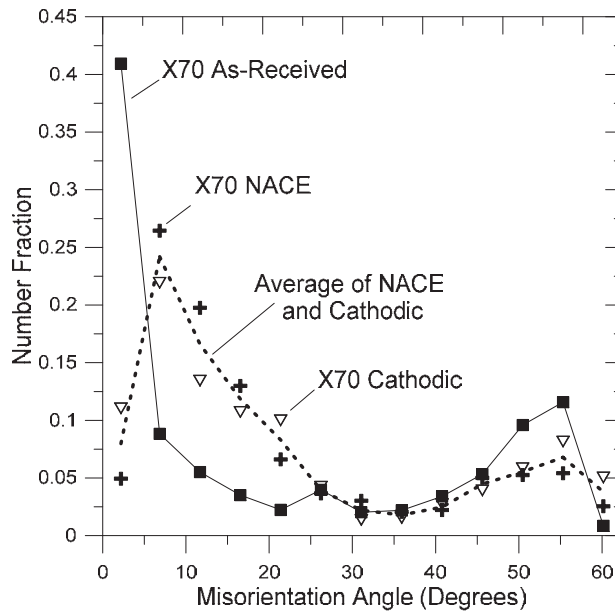
Figure 4. Mackenzie plot of number fraction of misorientation angles for the X70 AR microstructure and cracked boundaries averaged for the NACE and cathodically charged X70 specimens plotted with a dashed line.

Boundaries are defined using five parameters; three describe the misorientation matrix necessary to bring two neighboring grain orientations into coincidence,<sup>20,21</sup> and two describe the boundary plane orientation.<sup>22</sup> The misorientation matrix describes the axis and angle of rotation necessary to bring two orientations into coincidence. Examinations of boundary character often consider misorientation angle as a function of frequency of occurrence, known as Mackenzie plots.<sup>20</sup> Mackenzie plots from the AR microstructure and grains adjacent to cracked boundaries in the hydrogen charged samples are shown in Figure 4, where the data represent boundaries that fall within a  $5^\circ$  bin. The misorientation angle profiles for the cracked boundaries from the cathodically charged and the NACE TM0284 charged X70 alloy are similar. Both charging conditions had the highest number fraction of cracked boundaries at  $5$  to  $10^\circ$  misorientation and another peak around  $50$ - $55^\circ$  misorientation. Because the two charging conditions trend so similarly, the average number fraction was calculated and is represented as a dotted line in Figure 4. Very low angle boundaries between  $2$  to  $5^\circ$  misorientation appear at a much lower number fraction in the cracked boundaries than in the AR X70 material. In addition, boundaries with about  $5$  to  $20^\circ$  misorientation appear more frequently in the cracked boundaries than in the AR material. The misorientation distributions for both the AR and cracked boundaries nearly coincide from  $25$  to  $45^\circ$  misorientation. Lastly, the cracked boundaries have a lower number fraction in the  $45$  to  $62.5^\circ$  misorientation range than the AR X70 specimens. This analysis of the misorientation angle distributions could indicate that  $5$  to  $20^\circ$  misorientations are more susceptible to cracking, while  $2$  to  $5^\circ$  and  $45$  to  $60^\circ$  misorientations are less susceptible.

An example of a cracked region is shown in Figure 8a and b, which are micrographs of a cracked region from an X70 sample cathodically charged with hydrogen. Figure 8a is an EBSD IQ map with boundary misorientations adjacent to the crack overlaid and M/A regions identified. Figure 8b is an IPF map with data for with CI is less than 0.2 shown in black and average misorientations across the crack overlaid. Figure 8b contains a large region with a similar orientation. These large regions of similar orientation are often observed adjacent to cracks. There is both dislocation substructure and high angle grain boundaries present within this region shown in Figure 8a. It is interpreted that the cracks through the low misorientation regions ( $2$  to  $5^\circ$ ) are transgranular, and thus, the crack propagated both transgranularly and intergranularly in this region. The range of misorientations overlaid in Figure 8b is reflective of that shown in the Mackenzie plot, where the majority of the cracking occurs in misorientations with  $5$  to  $25^\circ$ , with a smaller amount of cracking from  $45$  to  $60^\circ$  misorientation. It is possible that the high density of boundaries less than  $25^\circ$  misorientation within these large regions in the X70 steel are more susceptible to cracking, as  $5$  to  $25^\circ$  misorientation boundaries were shown to be more susceptible to HIC (Figure 4).

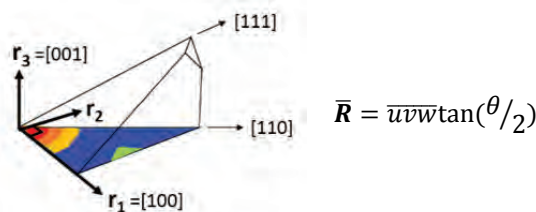
Figure 5. Schematic of Rodriguez-Frank space for cubic structures used for misorientation distribution functions.

To gain a more complete understanding of the boundary structures present in a material, both the misorientation angle and axis of rotation in the misorientation matrix must be considered. The misorientation matrix is most often described using an angle/axis pair, where the misorientation angle ( $\theta$ ) is the minimum rotation necessary to bring two adjacent grains into coincidence, and the misorientation axis ( $[uvw]$ ) is the direction about which the rotation occurs.<sup>23</sup> Misorientation angle and axis pairs are often denoted using the notation  $\theta \parallel [uvw]$ , meaning a misorientation of  $\theta^\circ$  about a  $[uvw]$  axis. This notation will also be used in the current work. Misorientation distribution functions (MDF) are calculated from EBSD data and used to represent boundary character.<sup>20-25</sup> MDFs in Rodriguez-Frank (RF) space use the misorientation axis and angle to calculate the Rodriguez vector  $\bar{R}$ , which is shown in Figure 5 where  $uvw$  is the unit vector axis of misorientation and  $\theta$  is the angle of misorientation.<sup>26</sup> The components of  $\bar{R}$  are ( $r_1, r_2, r_3$ ), and their unit vectors are shown in Figure 5. The shape of RF space is highly dependent on crystal symmetry. Due to the symmetry implicit in cubic structures, the fundamental zone of RF space, represented as a truncated cube, can be reduced to the shape shown in Figure 5 for materials with cubic symmetry.

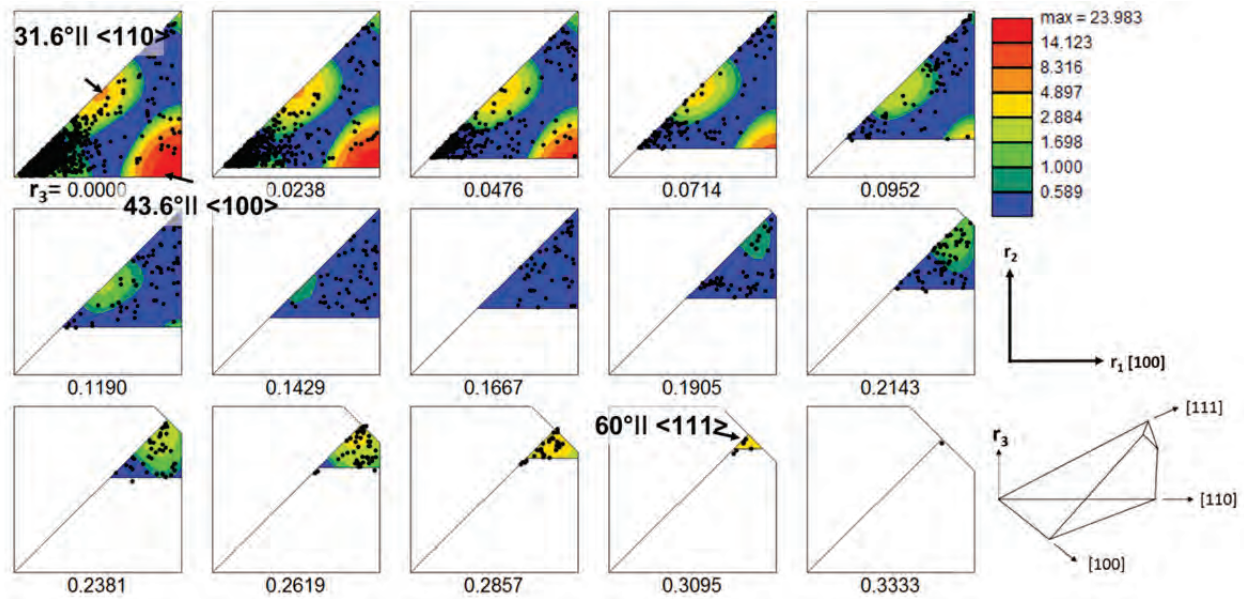
Figure 6 Misorientation distribution function in RF space for the as-received X70 steel with discrete misorientation angle/axis pairs from cracked boundaries overlaid as black dots. Locations of three special boundaries with high multiples of a random distribution are also overlaid for reference (*color image – see electronic copy*).

Figure 6 is an MDF plot in RF space of the AR X70 microstructure (contour plot) with black dots overlaid that signify discrete points calculated across cracked boundaries in both NACE and cathodically charged conditions. The legend in Figure 6 is in units of multiples of a random distribution (MRD). The red regions in Figure 6 indicate maxima that occur in the X70 MDF with MRD of about 24 and near a  $43.6^\circ \parallel \langle 100 \rangle$  axis/angle pair. The next highest value in MRD appears around 8.3 in a region near  $31.6^\circ \parallel \langle 110 \rangle$ . Lastly, there is a region with 4.9 MRD that is near  $60^\circ \parallel \langle 111 \rangle$  in axis/angle notation. Using the OIM<sup>TM</sup> software, the number fraction of each of these boundary types in the as-received X70 microstructure was calculated for data points with CI greater than 0.2. The resulting number fractions were 0.059 at  $60^\circ \parallel \langle 111 \rangle$ , 0.0029 at  $43.6^\circ \parallel \langle 100 \rangle$ , and 0.00049 at  $31.6^\circ \parallel \langle 110 \rangle$ , all in terms of number fraction.

A comparison of the AR microstructure to the hydrogen charged microstructure in RF space (Figure 6) reveals that the misorientations across cracks (black dots) are randomly distributed through RF space with a few exceptions. A large frequency of low angle boundary cracks in the hydrogen charged samples are shown by the high density of black dots representing cracked misorientations, which is consistent with the large number fraction of 5 to 10° misorientation in Figure 4. Interestingly, Figure 6 also reveals that there is a lack of black dots near the  $43.6^\circ \parallel \langle 100 \rangle$  misorientation, which

could indicate that misorientations near  $43.6^\circ \parallel \langle 100 \rangle$  are resistant to HIC. It is important to note that Figure 6 does not distinguish between ferrite grain boundaries and phase boundaries. The resistance of  $43.6^\circ \parallel \langle 100 \rangle$  boundaries to crack has also been observed by other researchers in low carbon ferrite/pearlite steel.<sup>11</sup> Similarly, there are not many black dots near the  $31.6^\circ \parallel \langle 110 \rangle$  misorientations. Therefore, boundaries with misorientation near  $31.6^\circ \parallel \langle 110 \rangle$  could also be resistant to cracking but are present in the AR microstructure much less frequently than the  $43.6^\circ \parallel \langle 100 \rangle$  boundaries. In contrast, the  $60^\circ \parallel \langle 111 \rangle$  misorientations do not appear resistant to cracking.

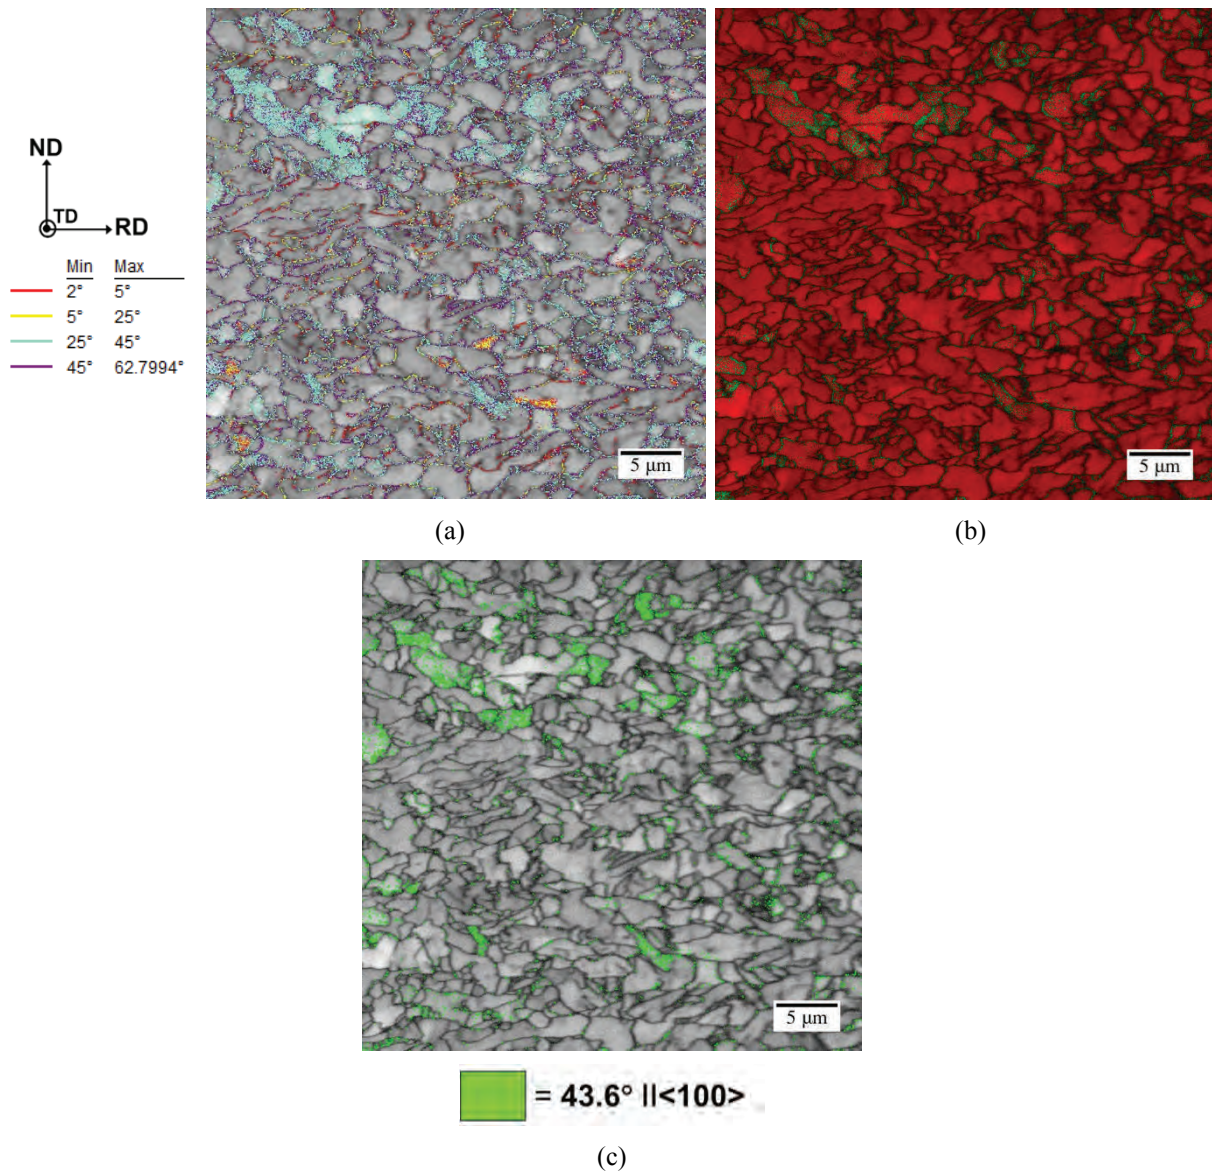
Figure 7. EBSD IQ maps from the AR X70 steel (a) with boundary misorientations overlaid per the legend to the left, (b) with phases overlaid where red indicates a point indexed as ferrite and green indicates a point indexed as cementite, and (c) with special  $43.6^\circ \parallel \langle 100 \rangle$  boundaries overlaid in green (*color image – see electronic copy*).

Figures 7a, b and c are IQ maps from the AR X70 steel with misorientation (Figure 7a), phase (Figure 7b), and  $43.6^\circ \parallel \langle 100 \rangle \pm 5^\circ$  misorientation (Figure 7c) overlaid; with all data points included. Figure 7a shows there is substructure within some ferrite grains as indicated by the red  $2$  to  $5^\circ$  misorientation boundaries; boundaries with these misorientations had relatively high number fractions in the Mackenzie plot shown in Figure 5. There is a small peak in the Mackenzie plot for the as-received microstructure near  $30^\circ$  misorientation as shown in Figure 5; these boundaries are included in the  $25$ - $45^\circ$  misorientations, shown as light blue points in Figure 7a. Figure 7b is a phase map with ferritic regions colored in red and cementite regions colored in green. The regions that appear to be rich in cementite in Figure 7b largely correlate to the regions with  $25$  to  $45^\circ$  misorientation in Figure 7a, including boundaries near  $30^\circ$  misorientation. In addition, the regions rich in cementite are low in confidence index.

The location of misorientations within  $\pm 5^\circ$  of  $43.6^\circ \parallel \langle 100 \rangle$  are shown on the IQ map in Figure 7c. Regions dense in  $43.6^\circ \parallel \langle 100 \rangle$  boundaries are correlated to low confidence indices in the as-received microstructure. Further, the regions rich in  $43.6^\circ \parallel \langle 100 \rangle$  misorientations in Figure 7c largely correspond to regions containing cementite in Figure 7b. The  $43.6^\circ \parallel \langle 100 \rangle$  misorientations all appear within ferrite grains rather than between grains, which indicates that the features are not grain boundaries, but rather are likely to represent phase boundaries between ferrite and cementite. It is important to note that the RF space used in the previous figures is for cubic symmetry, while  $\text{Fe}_3\text{C}$  has an orthorhombic lattice that is represented by a different fundamental zone shape in RF space. Thus, the specific axis/angle misorientation pairs associated with the cementite regions may not be those shown in the cubic RF space. However, the cubic RF space provides a tool to indicate regions in the microstructure dense in boundaries of a specific misorientation. Further work is necessary to determine the actual misorientations between ferrite and cementite constituents, which are currently highlighted as boundaries near  $43.6^\circ \parallel \langle 100 \rangle$ .

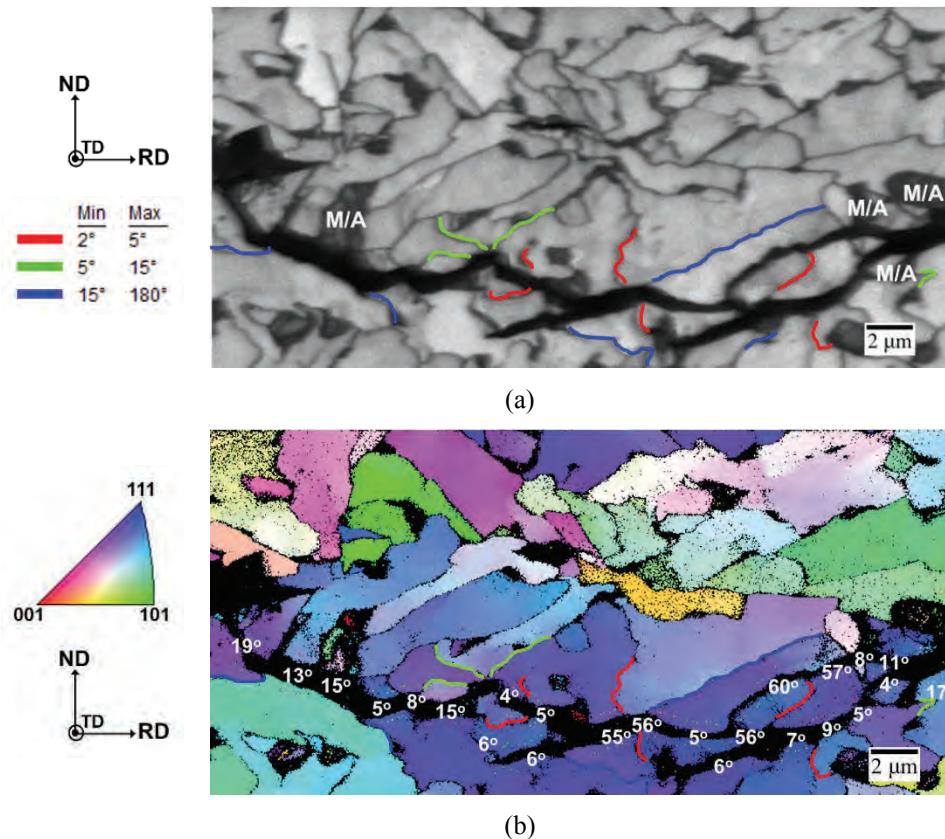
Figure 8. Micrographs obtained from an X70 steel charged using the cathodic charging method where (a) is an EBSD IQ map with grain boundary misorientations adjacent to the crack overlaid per the legend to the left, and (b) is an EBSD IPF map with points having less than 0.2 CI shown in black and average misorientations across the crack displayed (*color image – see electronic copy*).

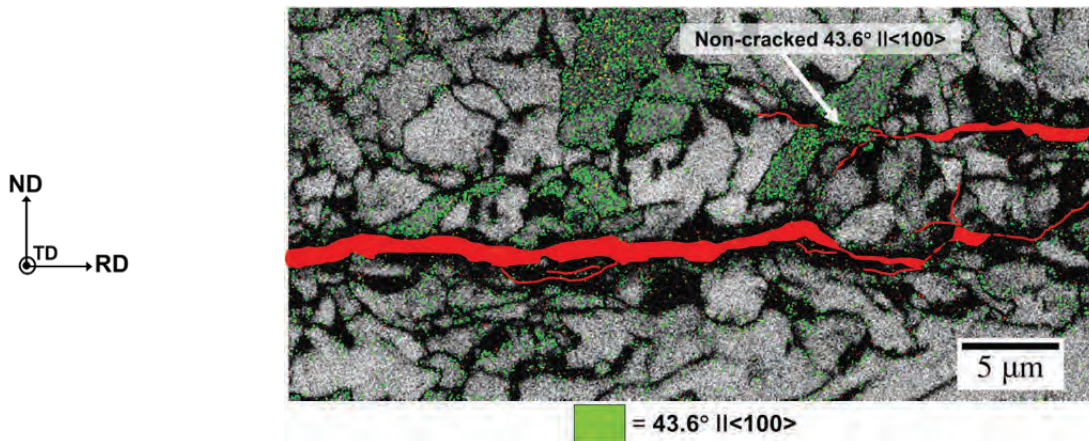
Figure 9. EBSD confidence index map from an X70 sample charged using the NACE TM0284 method with boundaries near  $43.6^\circ \parallel \langle 100 \rangle$  overlaid in green and the crack overlaid in red (*color image – see electronic copy*).

Figure 9 is a confidence index map with  $43.6^\circ \parallel \langle 100 \rangle \pm 2.8^\circ$  misorientations overlaid in green and the crack overlaid in red. The discrete misorientations calculated across the crack suggest that boundaries near  $43.6^\circ \parallel \langle 100 \rangle$  axis/angle pairs were resistant to cracking as discussed earlier (Figure 6). An example of a region in which the crack appears to avoid grains dense in boundaries near  $43.6^\circ \parallel \langle 100 \rangle$  is shown in Figure 9. The crack propagated adjacent to grains dense in boundaries near  $43.6^\circ \parallel \langle 100 \rangle$ , but the crack did not propagate through any of these regions. One example non-cracked region is highlighted with a white arrow in Figure 9. The HIC resistance of these regions, which also correspond to regions with greater amounts of cementite in EBSD maps, could be due to hydrogen trapping of the carbides and subsequent lack of hydrogen available for cracking.

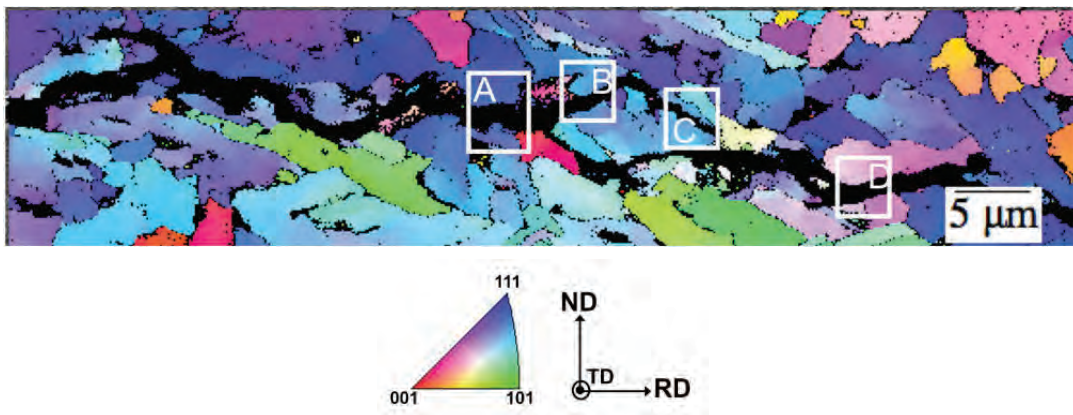
Figure 10. EBSD IPF map with CI <0.2 shown in black and regions for transgranular cracking analysis (A, B, C, and D) highlighted (*color image – see electronic copy*).

Figures 11a, b, c, and d correlate to regions A, B, C and D shown in Figure 10, respectively (*color image – see electronic copy*).

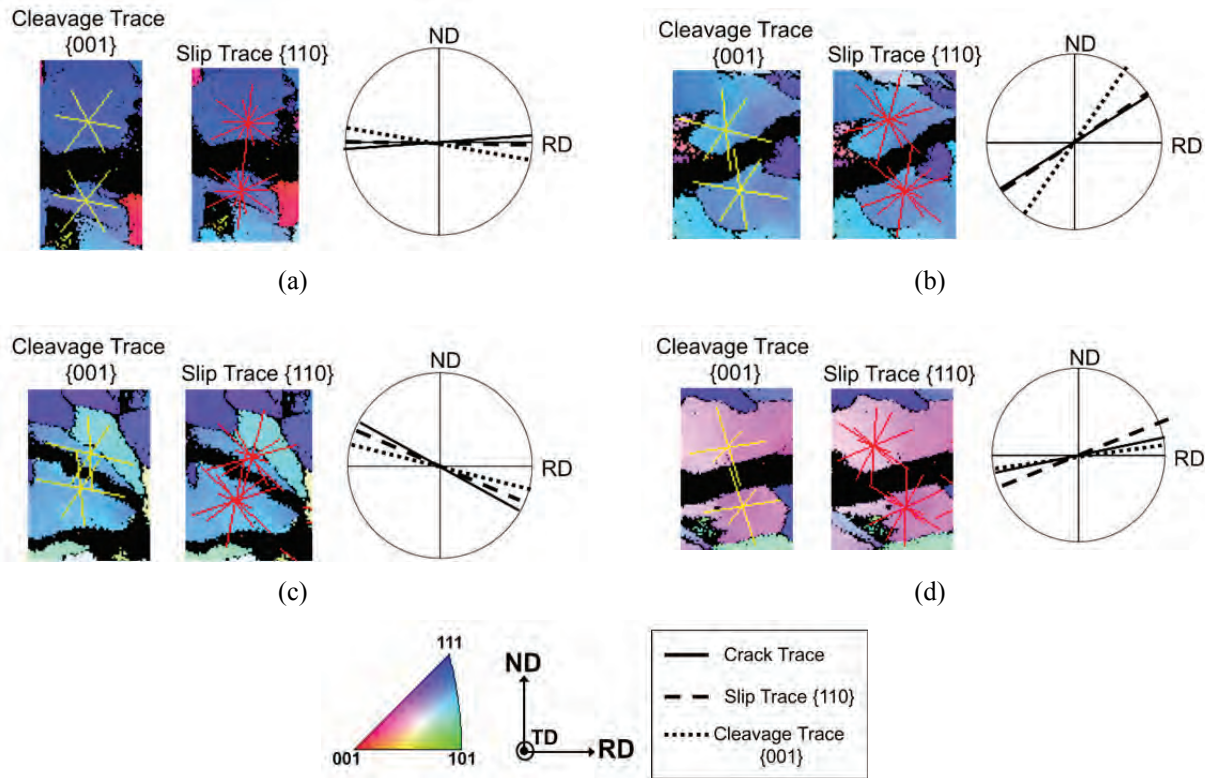
Figure 11. IPF maps with  $\{001\}$  cleavage traces (left) and  $\{110\}$  slip traces (right) overlaid, with a pole figure in the sample reference frame with the crack trace and closest slip and cleavage traces overlaid per the legend at bottom.

The crystallographic plane on which cracks occur is of interest to determine the mechanism by which cracks propagate transgranularly. In materials not exposed to hydrogen, brittle transgranular fracture occurs along  $\{100\}$  cleavage planes. The presence of hydrogen can allow for hydrogen enhanced localized plasticity (HELP) and adsorption induced dislocation emission (AIDE), which in turn can promote slip based transgranular fracture.<sup>27</sup> In Figure 10, an IPF map from a cathodically charged X70 specimen with CI less than 0.2 shown in black, shows various regions of transgranular cracking highlighted and labeled as A, B, C, and D. The crack trace is compared to traces of the nearest cleavage and slip planes in Figure 11. Region A is analyzed in Figure 11a, where all the crystallographically equivalent cleavage plane traces are shown on the left, and the equivalent  $\{110\}$  type slip plane traces are shown in the middle. The figure on the right in Figure 11a is a pole figure in the sample reference frame with the crack trace shown as a solid line. The closest slip and cleavage plane traces to the crack plane trace were obtained from the data produced by the OIM software and plotted on the stereographic projection to the right in Figure 11a. The crack trace in Region A, shown in Figure 11a, is closest to a slip plane. The cracks in Region B and Region C, shown in Figure 11b and Figure 11c, respectively, are also closer to slip plane traces than cleavage plane traces. The exception lies in Region D, shown in Figure 11d, where the crack trace is closest to a cleavage plane trace. Overall, the X70 alloy exhibited transgranular cracking near both slip and cleavage plane traces. Regions where the crack trace was closest to  $\{110\}$  slip plane traces, such as Regions A, B and C, could indicate that hydrogen is indeed playing a role in enhancing slip and affecting the plane of transgranular cracking.
